# Strength, Fatigue, and Fracture Toughness of Ti-6Al-4V Liner From a Composite Over-Wrapped Pressure Vessel

Jonathan A. Salem, Brad Lerch, John C. Thesken, and Jim Sutter Glenn Research Center, Cleveland, Ohio

Prepared for the Aging Aircraft 2008 sponsored by the NASA, FAA, U.S. Department of Defense, and ICAA Phoenix, Arizona, April 21–24, 2008

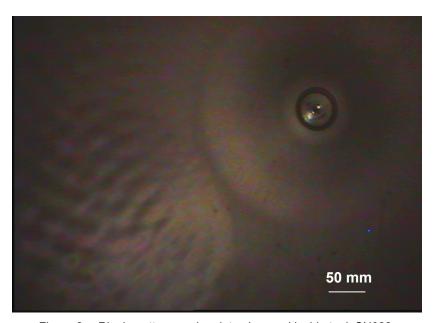
During boroscope inspections of several vessels at White Sands Test Facility (WSTF), the ripple patterns shown in figure 2 were observed. This pattern was attributed to either buckling of the liner during proof cycling or imprinting of the over-wrap pattern on the liner. In either event, the resultant ripples imply larger than ideal surface strains and thus some simulation of the fatigue life was deemed necessary. Similar but smaller patterns were noted on SN029 during inspections at NASA Glenn Research Center.

Figure 2.—Ripple patterns or imprints observed inside tank SN022.

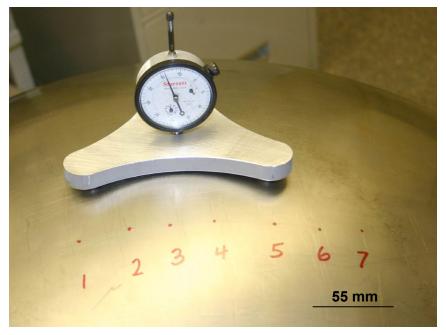
Measurements of the imprints on SN029 via the dial gage in figure 3 indicated a maximum displacement of  $\pm 0.002$  in. from the nominal centerline over a typical spacing of 1.25 in.

Figure 3.—Dial gage setup used to measure ripples in SN029. The points labeled 1 to 7 locate elliptical ripples or imprints on the tank liner.

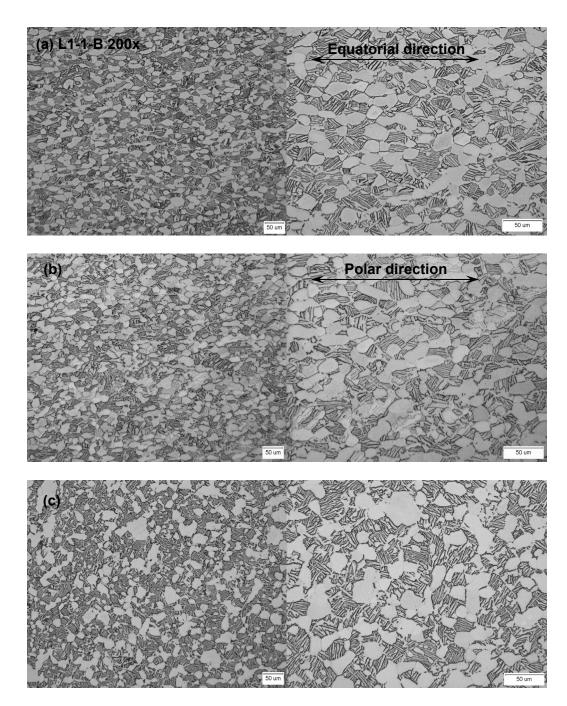
Table 1 gives chemical analysis results for the boss-transition region. The chemistry meets MIL-T-9047G requirements. Metallographic views of the boss-transition region are shown in figure 4. Planes normal to the polar and equatorial axes exhibit similar structure, however, the liner surface plane exhibits a coarser structure that does not correlate with either polar or equatorial views implying some variation in grain size through the thickness. This difference in grain size was also noted during x-ray diffraction measurements: diffraction patterns from the shell surface exhibit discontinuous Debye rings whereas patterns from the depth exhibited continuous lines, implying a grain structure difference. Views of the membrane region, which are more consistent, are shown in figure 5. Additional metallography of the boss transition region did not reveal a consistent through-thickness difference in structure. The microstructures in figures 4 and 5 are typical of those exhibited by Ti-6V-4Al.

Figure 4.—Metallographic views from the boss-transition region at two magnifications: (a) in the equatorial direction, (b) in the polar direction, and (c) into the vessel surface (radial).

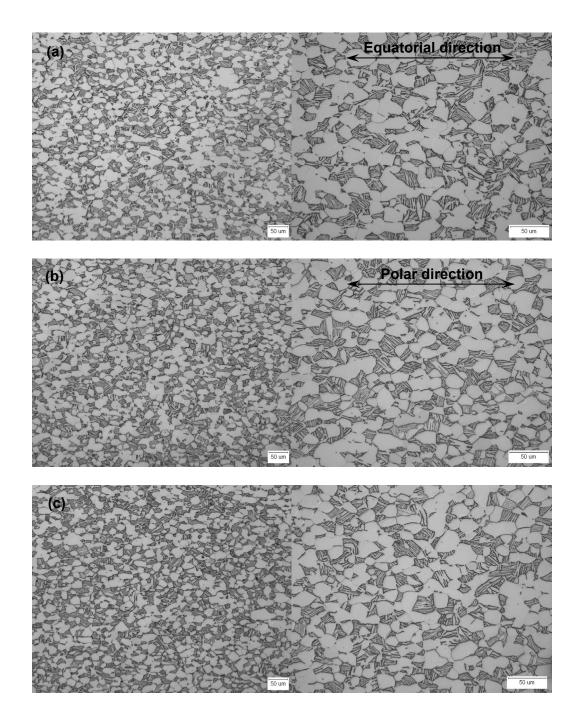
The average depth (into the tank surface) of 21 cracks emanating from the interior edge of metallographic planes normal to the equatorial direction of the membrane region was  $10\pm4~\mu m$ . Observation of 28 cracks on planes normal to the polar direction indicated a significantly smaller average crack size of  $5\pm3~\mu m$ . A maximum crack length of 20  $\mu m$  was observed. Much smaller, much less frequent cracks could be observed emanating from the tank exterior, implying that the polishing and etching process (described in the SN022 data pack) reduced the crack size. The bulk of the most visible cracks appeared to be nearly normal to the equatorial direction, however, cracks could be observed at other angles and determination of any bias in the crack pattern would require more significant sampling.

Figure 5.—Metallographic views from the membrane region at two magnifications: (a) in the equatorial direction, (b) in the polar direction, and (c) into the vessel surface (radial).

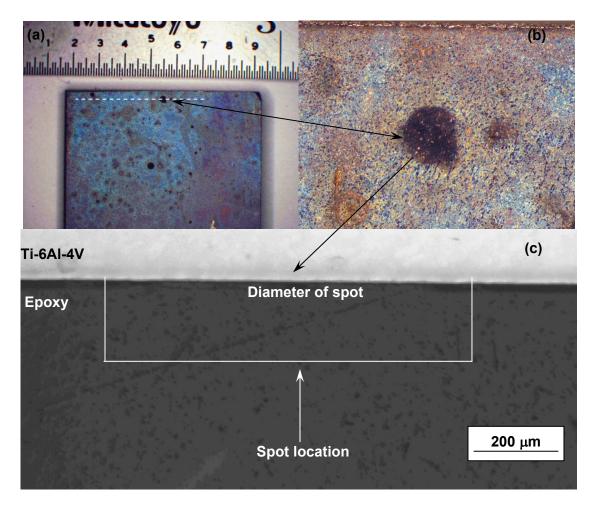
Observation of the cross section of the spots shown in figure 6 did not indicate significant depth or microstructural anomalies. The oxide layer was very thin ( $< 1 \mu m$ ) and no alpha case was apparent. Of more interest was the small, transgranular cracks emanating from the interior surface into alpha grains in the membrane region, as shown in figures 7 and 8. The cracks were speculated to be due to increased oxygen content.

Figure 6.—(a) and (b) Interior surface of liner showing blue heat tint and presence of spots. Dashed line indicates location of metallographic views. (c) Cross section of the spot.

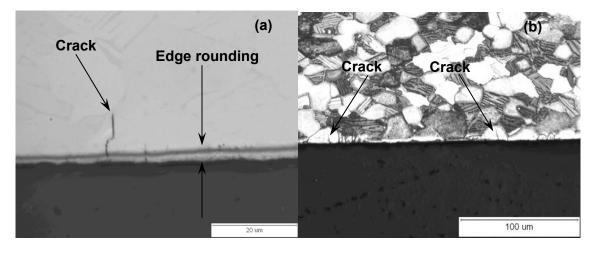
Figure 7.—Small surface cracks emanating from the tank interior at the spot: (a) as-polished and (b) etched.

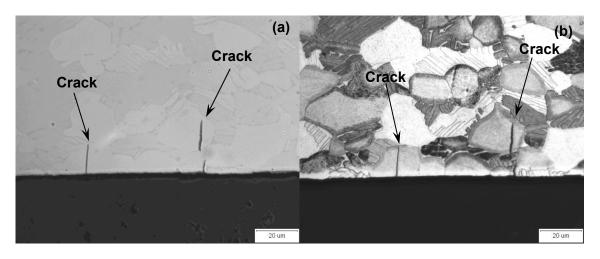
Figure 8.—Small surface cracks emanating from the tank interior away from the spot: (a) as-polished and (b) etched.

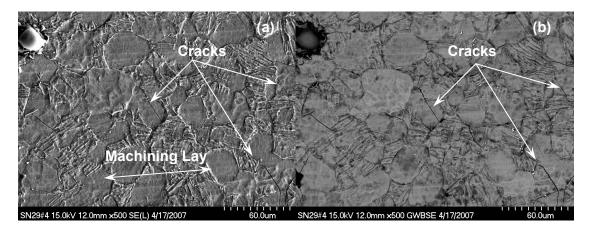
Further inspection using scanning electron microscopy indicated a network of transgranular cracks on the oxidized surface, as shown in figure 9. No cracks were apparent on the exterior surface (fig. 10), however, as discussed previously, the SN022 data pack indicates that the oxide layer was removed by polishing with an abrasive pad followed by an acid dip.

Figure 9.—Cracks on the inner surface of the liner as viewed with (a) secondary and (b) back scattered electrons.

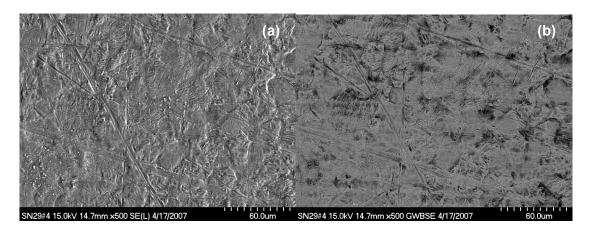
Figure 10.—Exterior surface of the liner as viewed with (a) secondary and (b) back scattered electrons. Cracks are not visible.

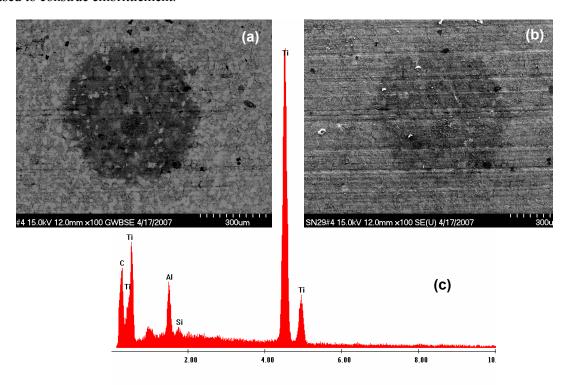
Chemical analysis of the spots via EDS indicated carbon, as shown in figure 11, implying that the spots are carbonaceous stains rather than corrosion. Chemical analysis of the oxygen content near the interior surface via EDS and microprobe x-ray mapping did not indicate increased oxygen or carbon content, as shown in figures 12 and 13. All elemental maps, with the exception of nickel, exhibit a uniform distribution from the interior to the edge, implying insignificant compositional change. Thus chemical variation cannot be used to construe embrittlement.

Figure 11.—Spots as viewed with (a) backscattered and (b) secondary electrons. (c) Chemical analysis indicating the presence of carbon.

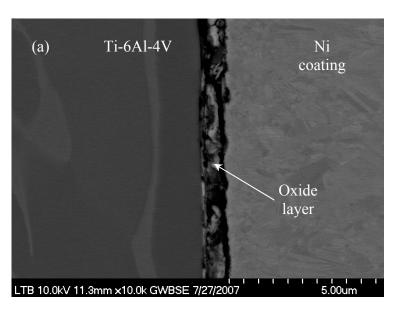
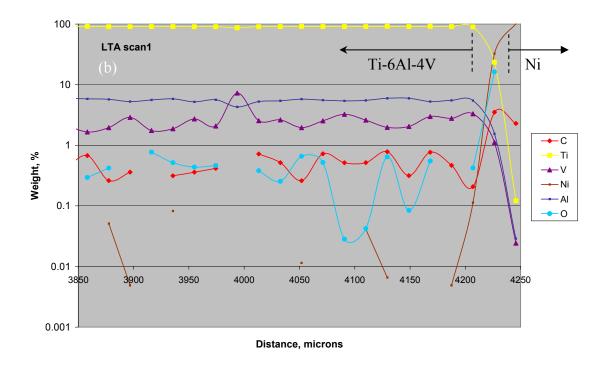
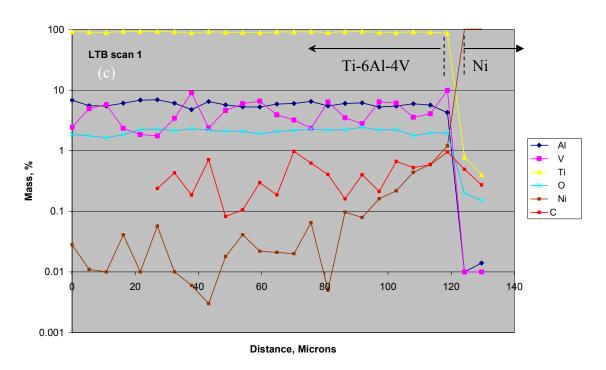
Figure 12.—(a) Cross section of oxide layer.

Figure 12.—Concluded. (b), (c) elemental line scans of the near surface region.

The gradual change in nickel is due to smearing of the coating during polishing. Thus the hypothesis that the microcracks are due to increased oxygen content, contaminant alpha grain embrittlement and the autofrettage cycle cannot be established. The cause of the cracks is unknown, but they may be due to the brittle oxide layer and the autofrettage cycle.

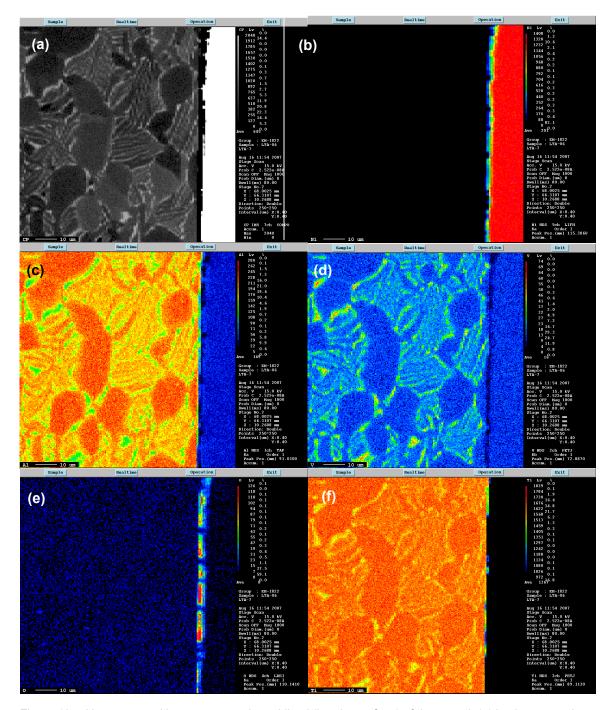
Figure 13.—X-ray composition maps near the oxidized (interior surface) of the vessel: (a) back-scattered electron image, (b) nickel, (c) aluminum, (d) vanadium, (e) oxygen, and (f) titanium. For (a), lighter colors imply higher atomic number elements. For (b) through (f), Reds and yellows imply high concentrations of the specified element, while blues and blacks imply low concentrations.

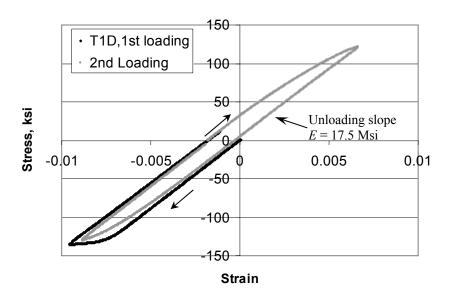
The Bauschinger effect is the reduction of yield strength after loading past yield in the opposite direction. It can be particularly significant for aluminum and titanium alloys. An example of the effect for the Ti-6Al-4V liner is shown in figure 18 where, after yielding in compression, tensile yield occurs more gradually and at substantially lower stresses (~85 ksi) than the usual 130 ksi. This results in a change in load sharing between the Kevlar overwrap and liner with multiple yield cycles, as occurred during the testing of SN011 (ref. 6).

Figure 18.—Load cycle exhibiting the Bauschinger effect. The first cycle was compression. The second cycle was tension followed by compression.

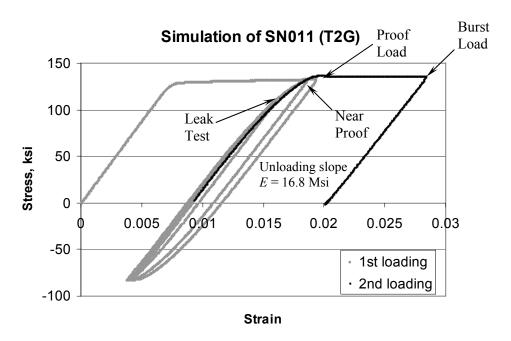
The uniaxial simulation is shown in figure 19. The test implies that the liner does exhibit reduced yield when reloaded to near proof pressure, and thus explains the observation of low vessel yield during burst testing. The Ti-6Al-4V liner material specimen, however, did sustain the desired loads and strains without catastrophic failure.

Figure 19.—Uniaxial, strain controlled simulation of SN011 burst test.

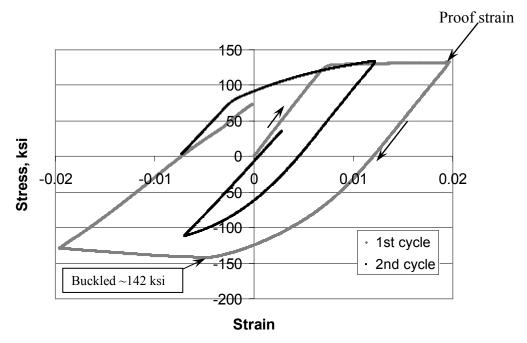
Figure 20.—Load history of the buckled test specimen.

The proof and buckling cycles are shown in figure 20, and the severely buckled specimen is shown in figure 21. The specimen exhibited a maximum unconstrained bending displacement of 0.024 in., whereas upon clamping in fixed grips the displacement was reduced to 0.008 in., which is somewhat larger than that observed on the surface of SN029 (fig. 3).

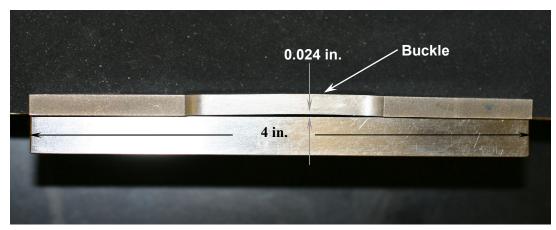
Figure 21.—Buckled test specimen.

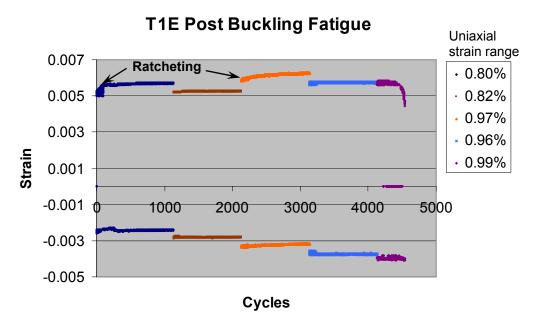
The post-buckling, cyclic load-controlled history is shown in figure 22. A uniaxial strain range of 1 percent was sought based on the biaxial operating range of 0.7 percent and equations (1) to (4). Initial

Figure 22.—Cyclic load history of the buckled test specimen under load control.

calculations based on figure 19 did not provide sufficient strain range due to work hardening of the material. Thus subsequent blocks of 1000 cycles were applied with increasing load levels until 1 percent was attained.
